EMBANKMENT CRITERIA AND PERFORMANCE REPORT FALL RIVER  
BASIN COLD BROOK LAKE SOUTH DAKOTA (U) ARMY ENGINEER  
DISTRICT OMAHA NEBR NOV 81

# EMBANKMENT CRITERIA AND PERFORMANCE REPORT

COLD BROOK LAKE, SOUTH DAKOTA

COLD BROOK DAM AND LAKE  
Cold Brook, Fall River Basin, South Dakota

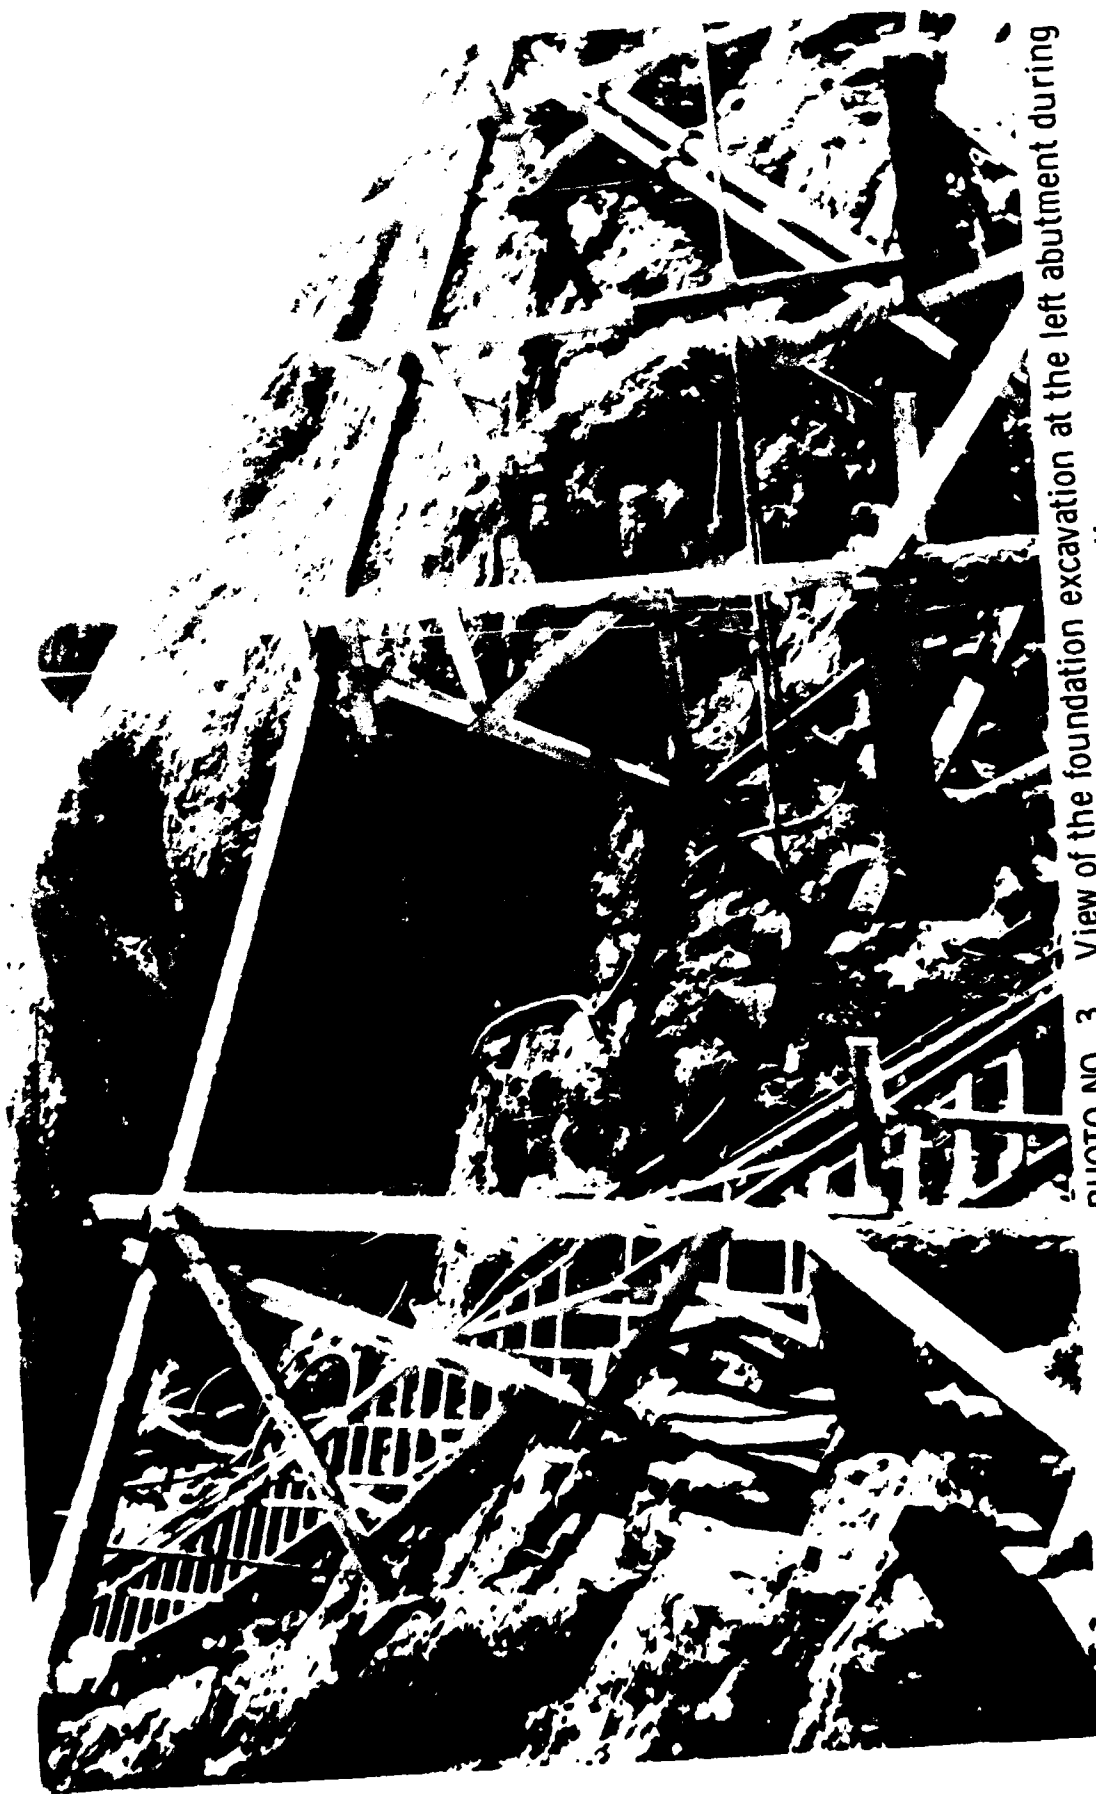
PHOTO NO. 3. View of the foundation excavation at the left abutment during drilling and grouting operations.

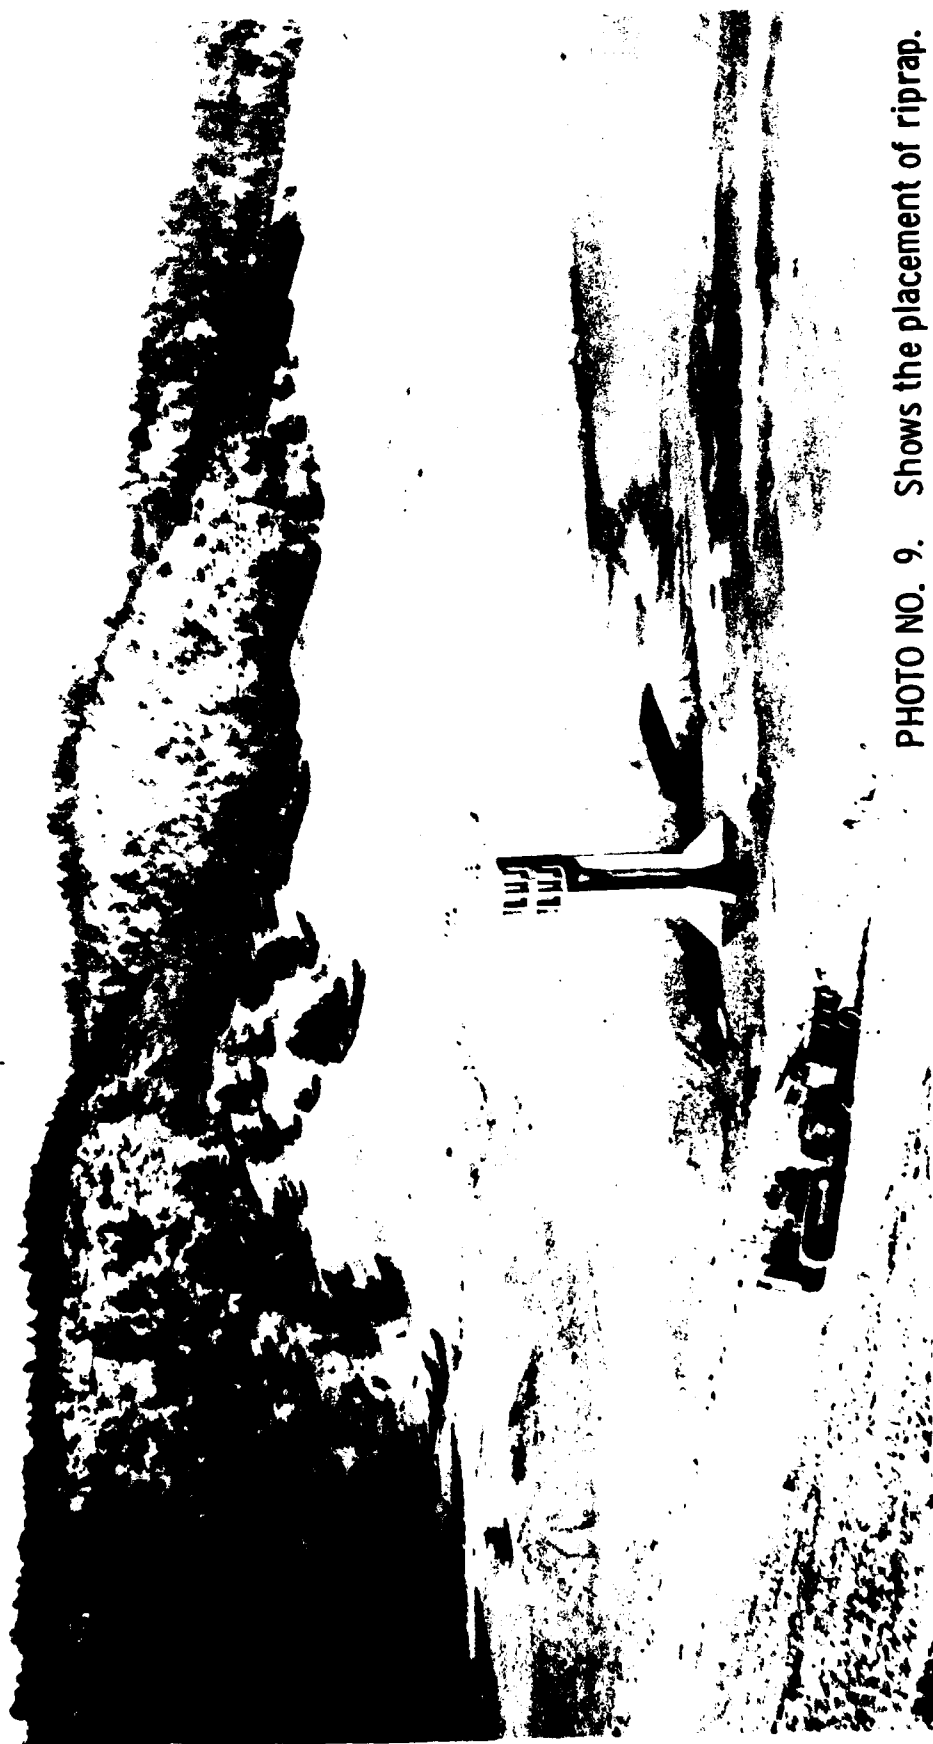
6.4.3. Riprap and Spall Placement. Photo 9 shows the method of riprap placement. It appears that the spalls were first placed on the slope and then the riprap was dumped into place from trucks. The final adjustments of the stones was then made by hand.

PHOTO NO. 9. Shows the placement of riprap.

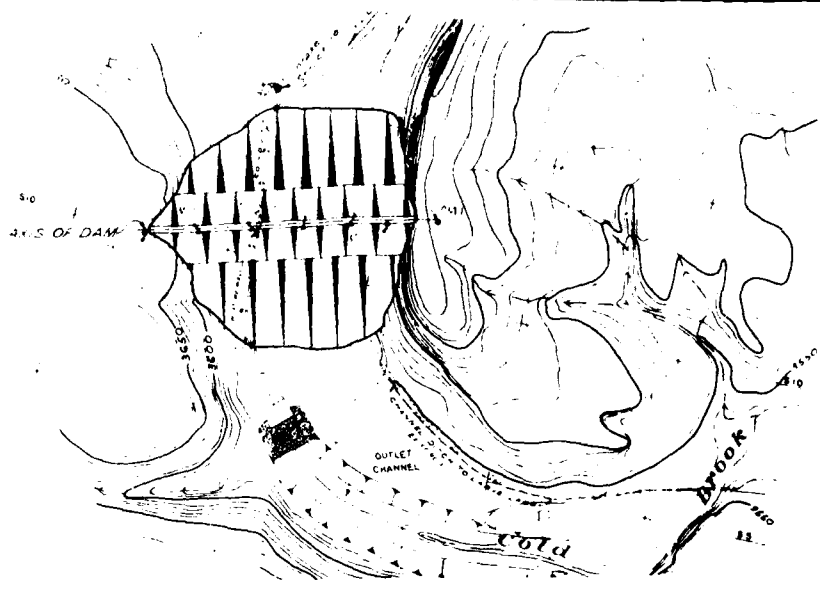
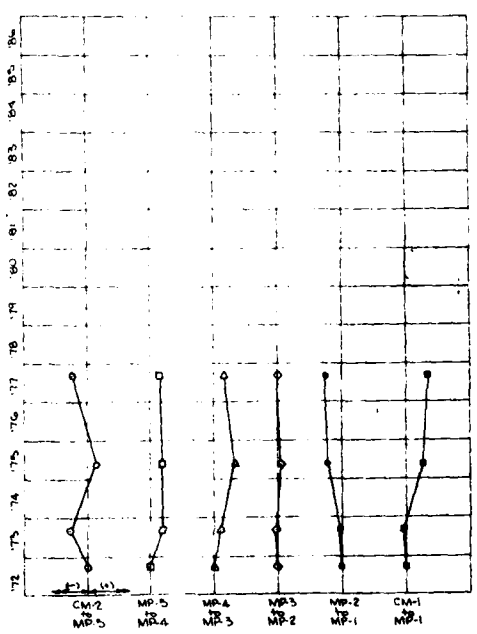
# GENERAL PLAN

5.2. Dam Crest Movement Pins. Plate 19 shows the locations and a typical installation for these movement pins. This plate also presents the movement readings taken to date. The maximum settlement observed is 0.12 feet and occurred at MP 5 which is near the right abutment. The maximum movement in the upstream-downstream direction is 0.08 feet upstream and occurs at MP 4. These movements are not considered significant.

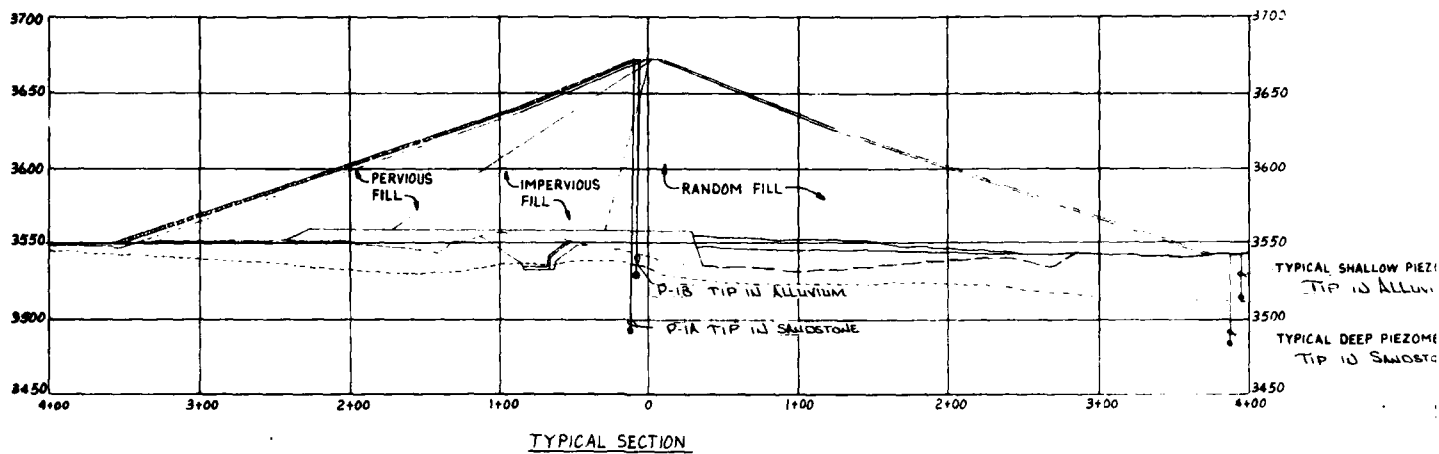
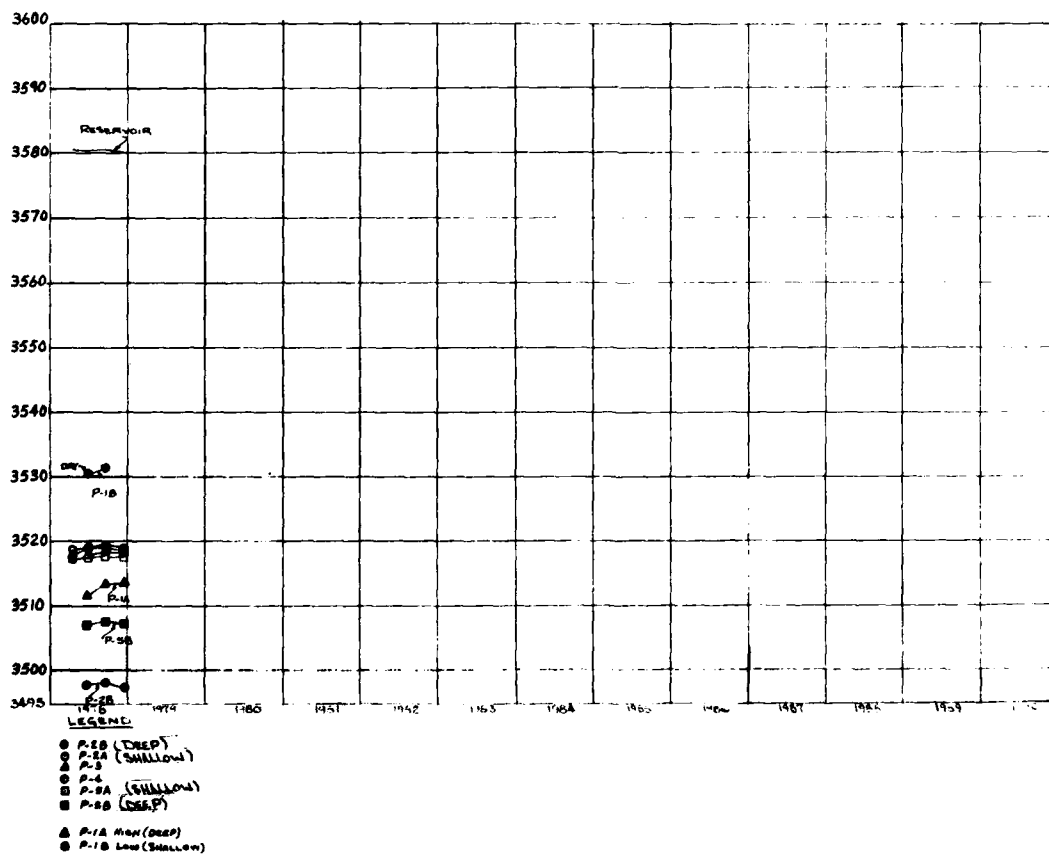
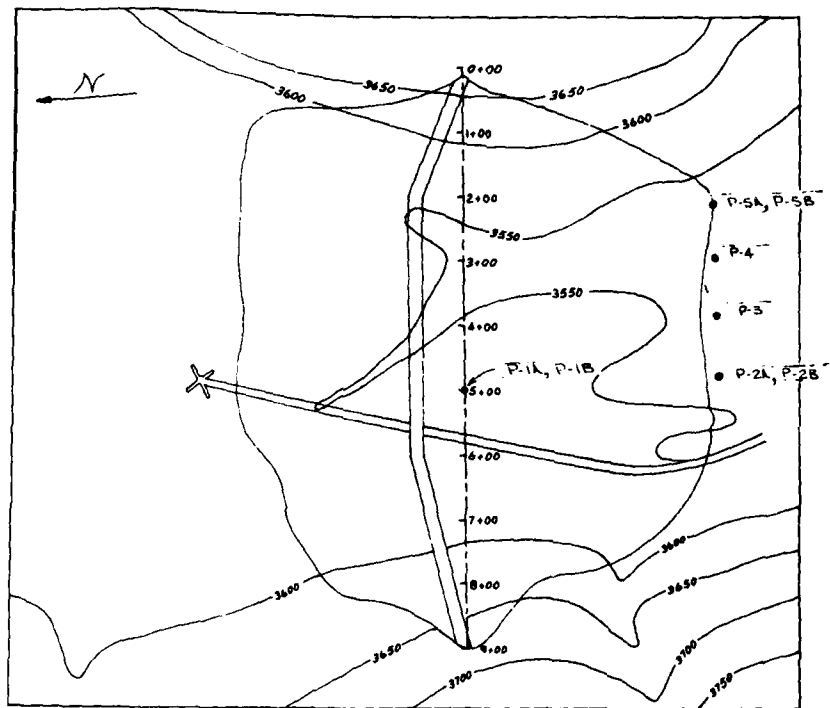
5.6. Piezometers. Plate 22 shows the location of the eight piezometers at this project. Also shown on this plate is a typical installation detail and a plot of the piezometric readings to date. Three of the piezometers (deep) monitor water levels in the sandstone bedrock. The other five piezometer (shallow) monitor water levels in the foundation alluvium. The readings to date show that there are no significant pressures under the embankment. This indicates that the foundation cutoff is effective for pool levels up to elevation 3585.
